# Case Histories

## Soil Guard® Bonded Fiber Matrix

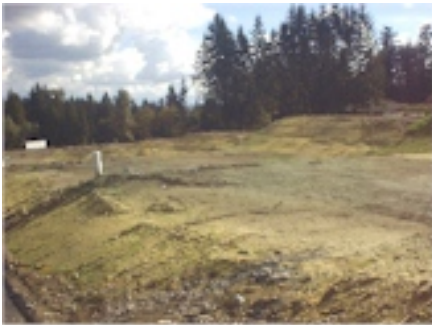
The Seattle area experienced a heavy rain event on Friday, October 8, 1999. Here are some photos of a Soil Guard job that was put down on Tuesday, September 28, 1999. This is a housing development in Redmond, WA. It is at the top of a hill with another development below as well as a Salmon-spawning creek.

The developer, Conner Homes chose to use Soil Guard on the bases of each home pad, instead of straw and tack. His reasons for using a more expensive application were:

- It costs him \$1,000 per day per lot when he gets red tagged. It's less costly in the long run to use Soil Guard.
- The erosion work takes less time, and his crews can be on-site sooner than if he did the three steps with Seed-Straw-Tack.
- Because his homes sell for \$250K to \$350K he does not want straw grass growing in peoples lawns. He also does not want straw grass growing in the lawns of neighboring homes. And Soil Guard won't blow away.

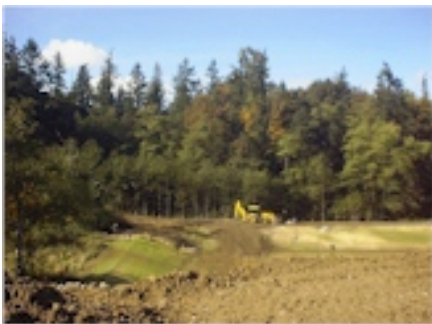
Here is Soil Guard® after the same 4" rain event. This is at a development on the Issaquah Plateau. They recorded 4" between midnight and noon. It continued to rain heavily throughout the day. The application was on September 20, 1999. It was done for the same developer, Conner Homes.

When this job was done there was some concern about the product being able to dry. The pond was designed to let water seep in from a side that is a natural wetland, and it was doing just that when the Soil Guard was applied.

The pond was  $\frac{3}{4}$  full of water the day before this picture was taken. Soil Guard® held up beautifully.
