# Case Histories

## Stream Bank Stabilization Project: Chehalis, WA

This project was a Lewis County Water Conservation District job to stabilize the banks of a small stream in a pasture found to support salmon fingerling.

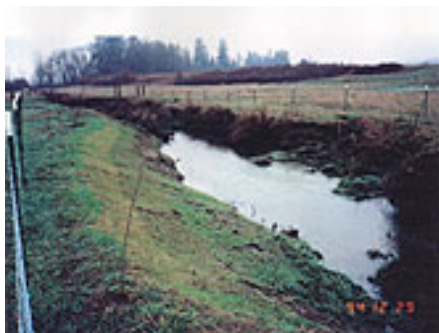
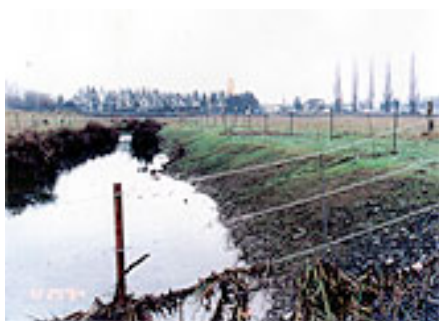
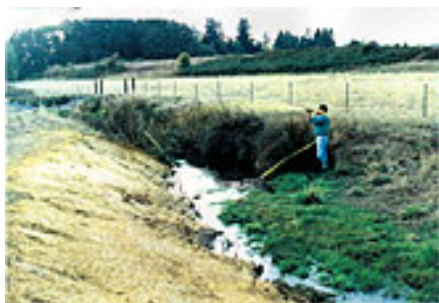
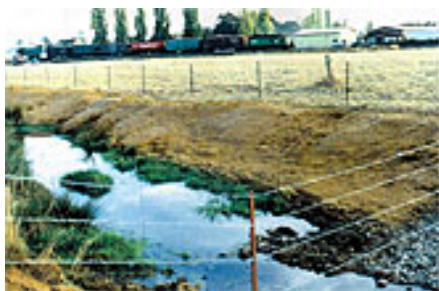
The stream had been damaged by cattle crossing and foraging near and in the stream. The project crew fenced off the stream the full length of the pasture leaving one area for the cattle to cross. They then laid the stream bank back to about 5:1 in four areas. Each of these areas were treated with live willow stickings up the fresh cut bank and one three-foot wide strip of jute blanketing was placed at the low flow water line.

A 4,000 pound/acre treatment of Soil Guard® was applied to each of the four areas by Country Green on October 11, 1994. Several large storm events have occurred since application. This stream rose more than two feet on one occasion with very little damage to the Soil Guard® as indicated by photos above. Vegetative cover is approximately 80% and no erosion is apparent.
